***HARRY AND LAURA NOHR CHAPTER OF
TROUT UNLIMITED***

***BLUE RIVER HABITAT IMPROVEMENT PROJECT
2016***

Report Prepared by the
Project Committee
Harry and Laura Nohr Chapter of Trout Unlimited

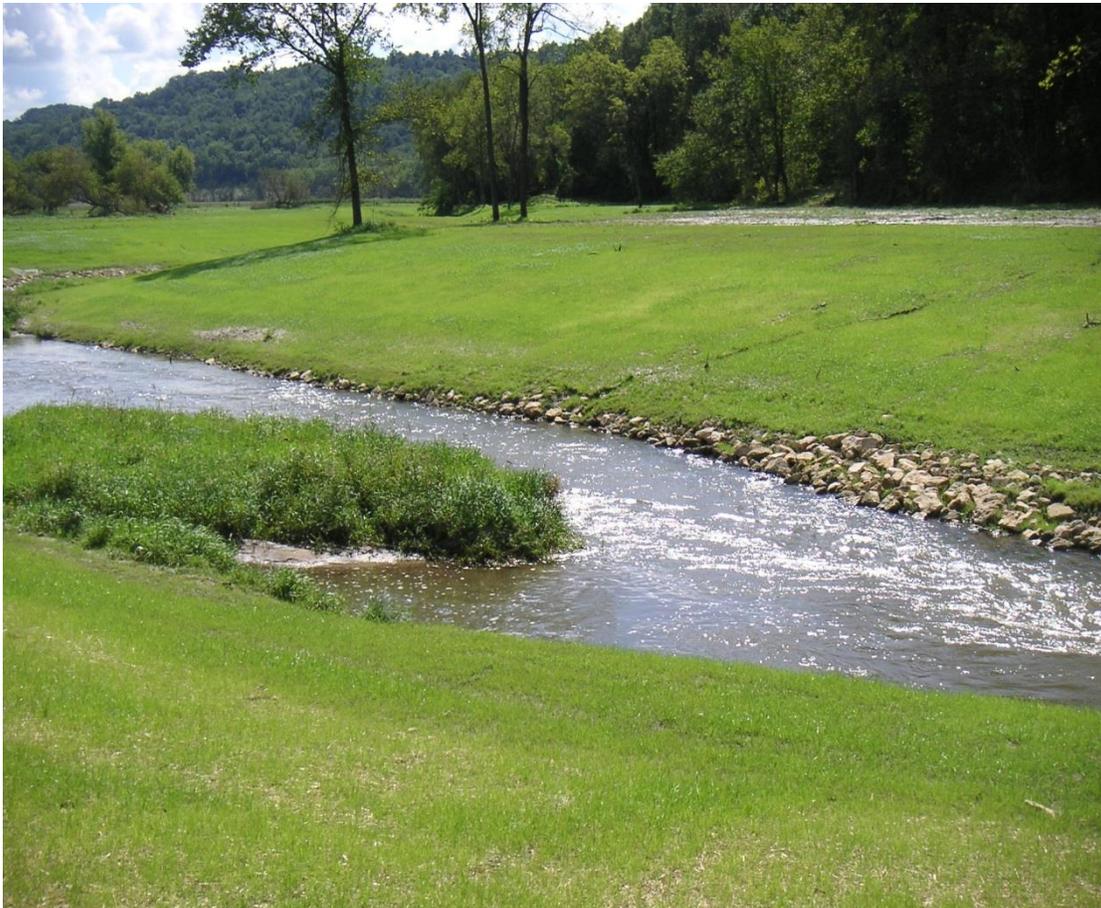
A back water area created when a tall vertical bank was tapered to an island

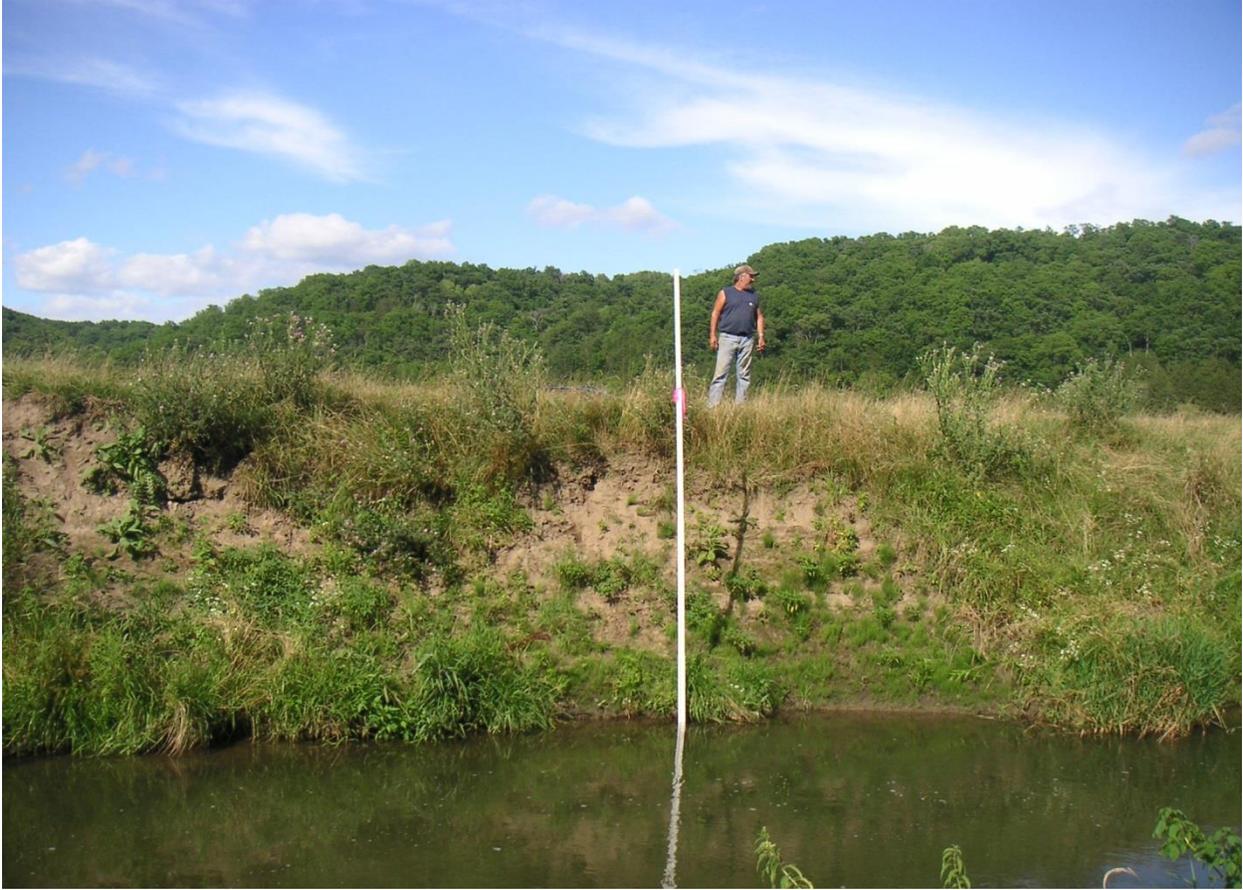
Pink ribbon was tied on at twelve feet.

This project started where our 2012-2013 work concluded. The habitat in this section of stream was as bad, or worse than the 2012-2013 site. The entire section was severely entrenched with vertical eroding banks as high as 13 feet. Prior to the project, the stream held trout but the habitat was in poor condition. The stream bed was heavily silted in most places and very wide in some. The project section ran through actively grazed pasture. In addition, much of this stream section ran against steep hillsides undercutting trees which caused continuously eroding banks and made the work much more difficult. About half way through the project site a severely incised ditch extended from the stream across the pasture to a fence. This ditch drains a huge area of uplands. A crossing needed to be installed across the ditch to enable access to the upper half of the project.

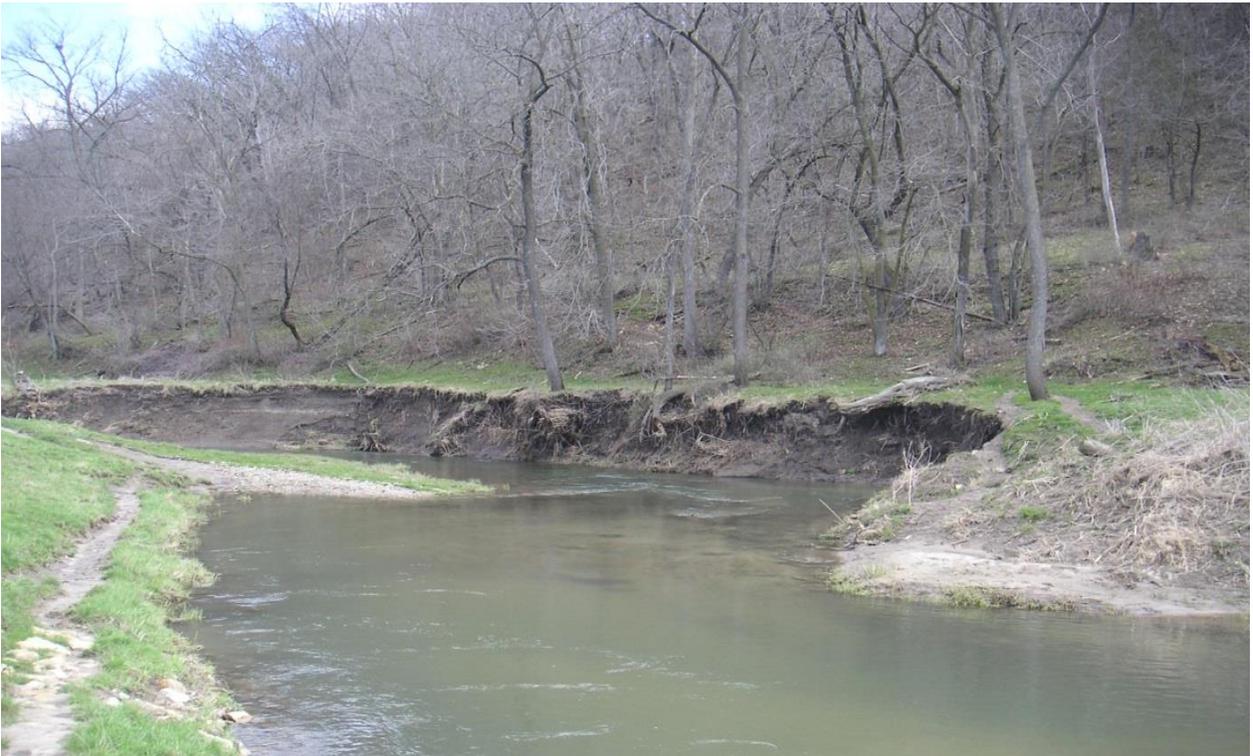
Upper stream section in this photo shows work that was finished in the summer before all the rain events that postponed the lower third of the project (part of which is visible in the lower part of this picture) into the fall.

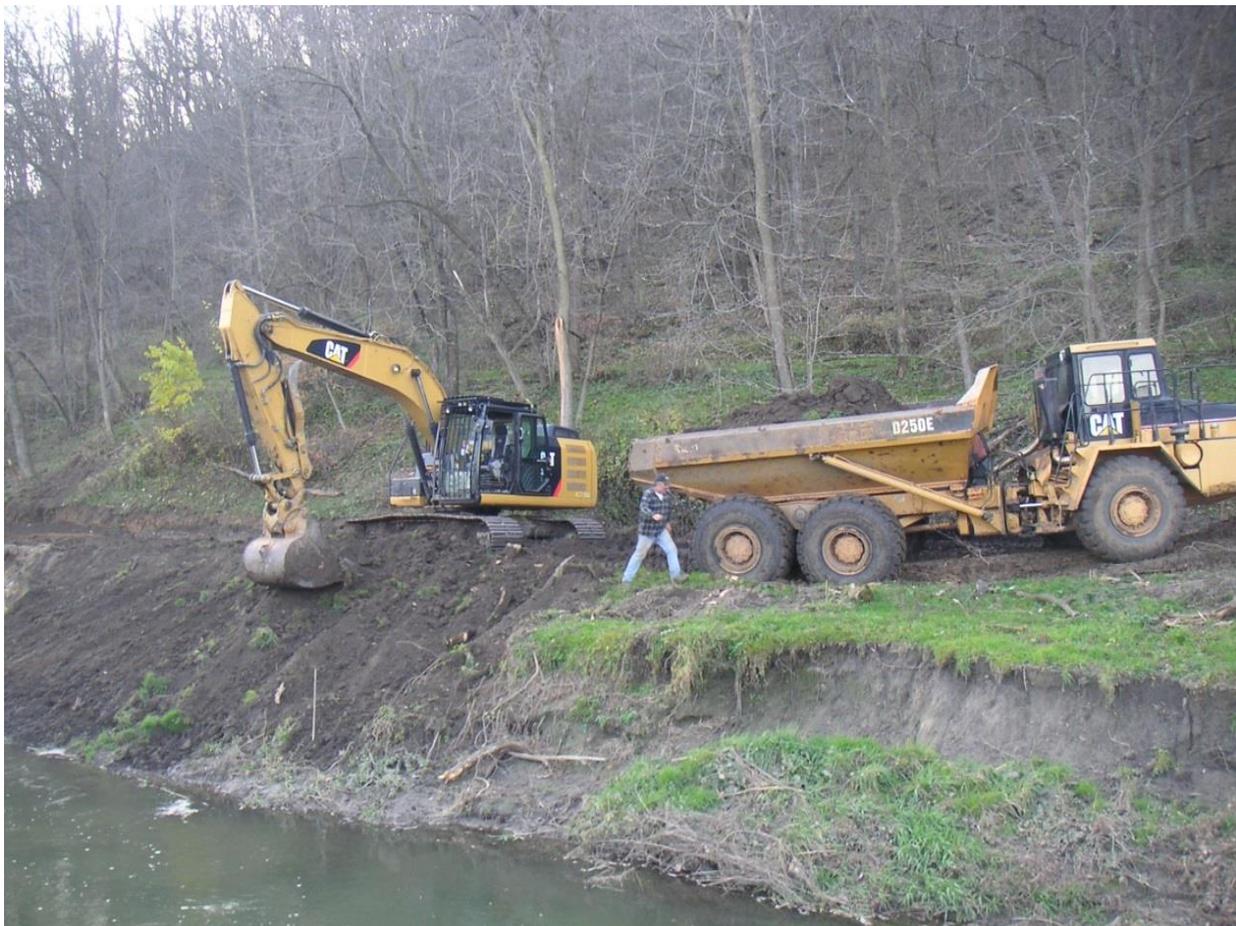
A section of stream against the hillside being tapered. Notice the large section of bank that sluffed off during one of the large rain events that occurred while the work was in progress. This happened in several other areas as well.

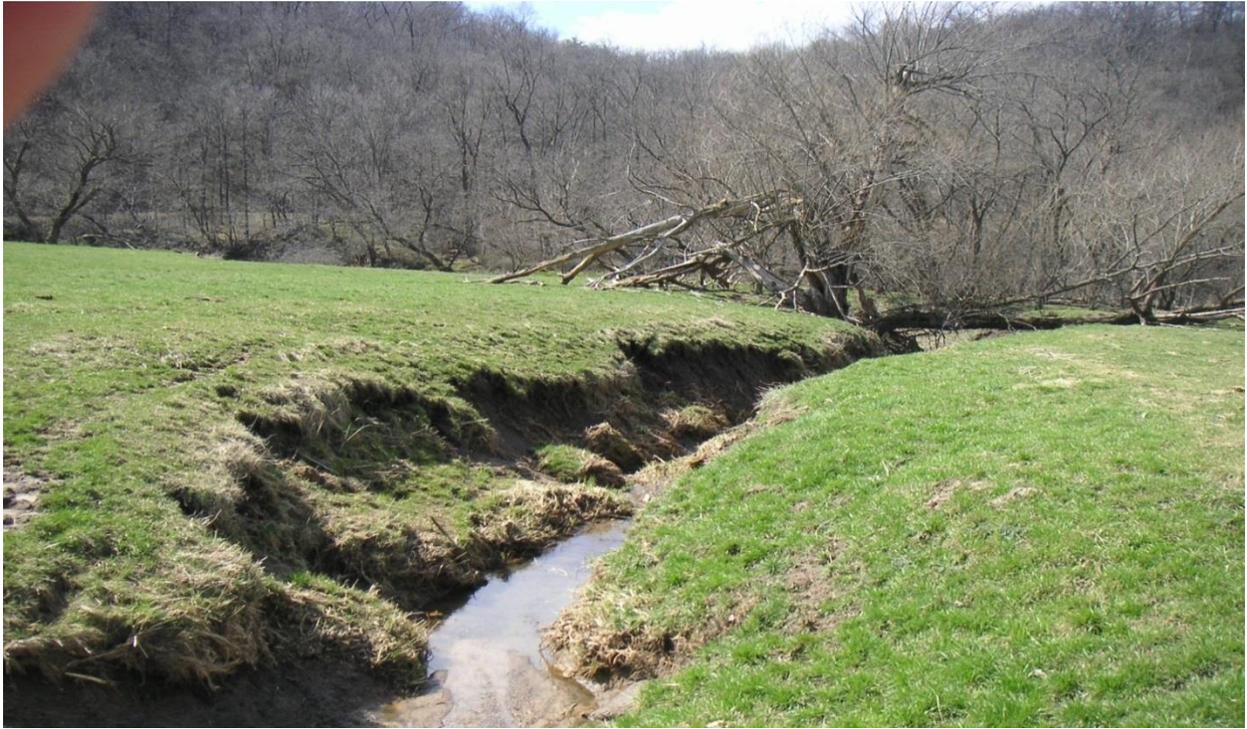
Before and after photos of drainage ditch that crossed the pasture. To access the upper end of the project we had to be able to cross this ditch. Three large pipes were installed in the upper end and covered with rock and breaker run which allowed trucks to cross. When the work was finished above this site the banks were sloped back and seeded, the pipes were removed, and the rock was used to make a cattle crossing that fit the contour of the ditch.

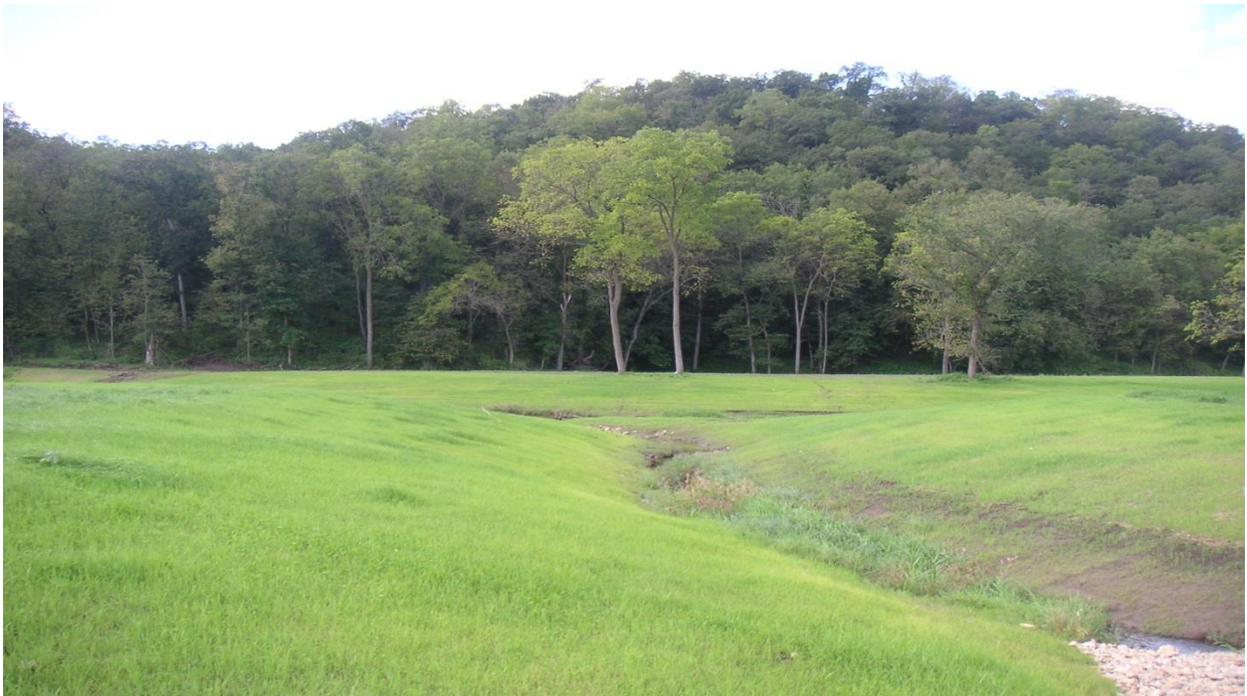
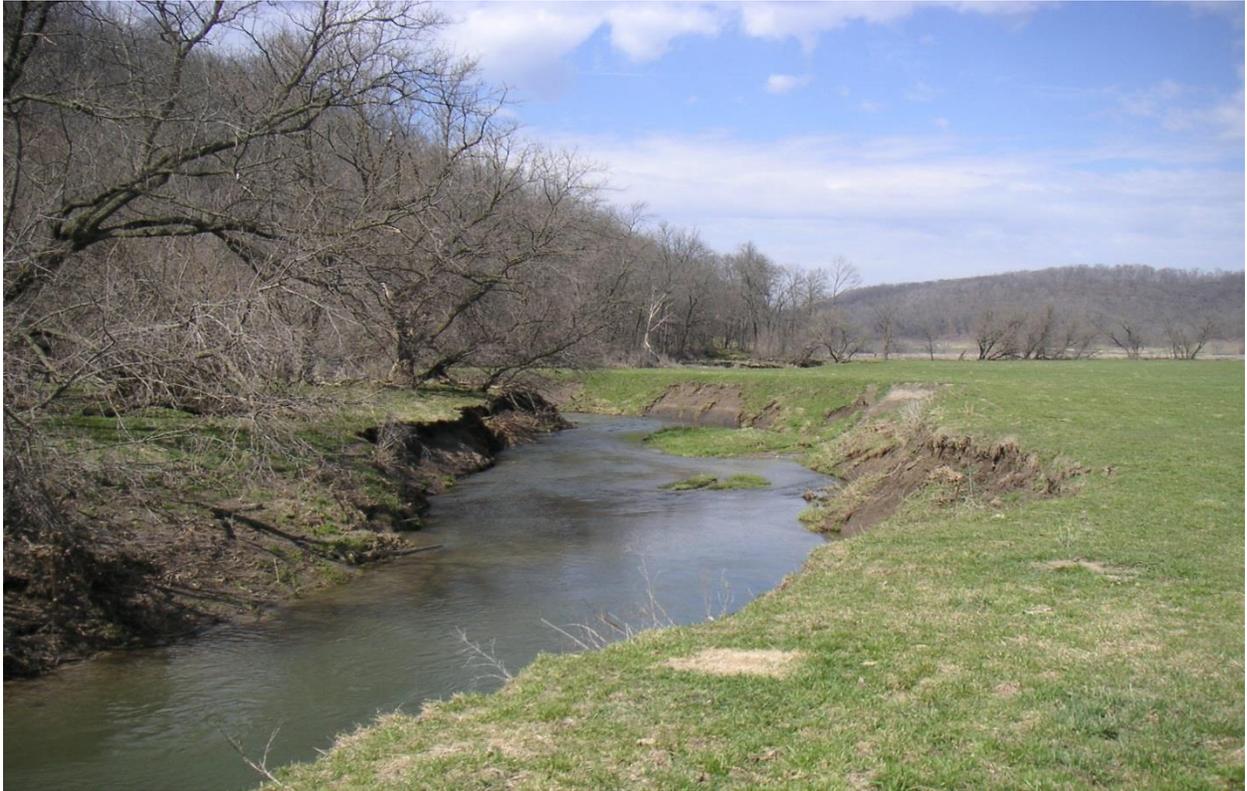
The photo above shows the banks before shaping. The lower photo shows the inside bank with box elders removed and the start of bank shaping. This section is just below where the drainage ditch enters the stream. The majority of the project site consisted of vertical banks similar to these or higher on both sides of the stream.

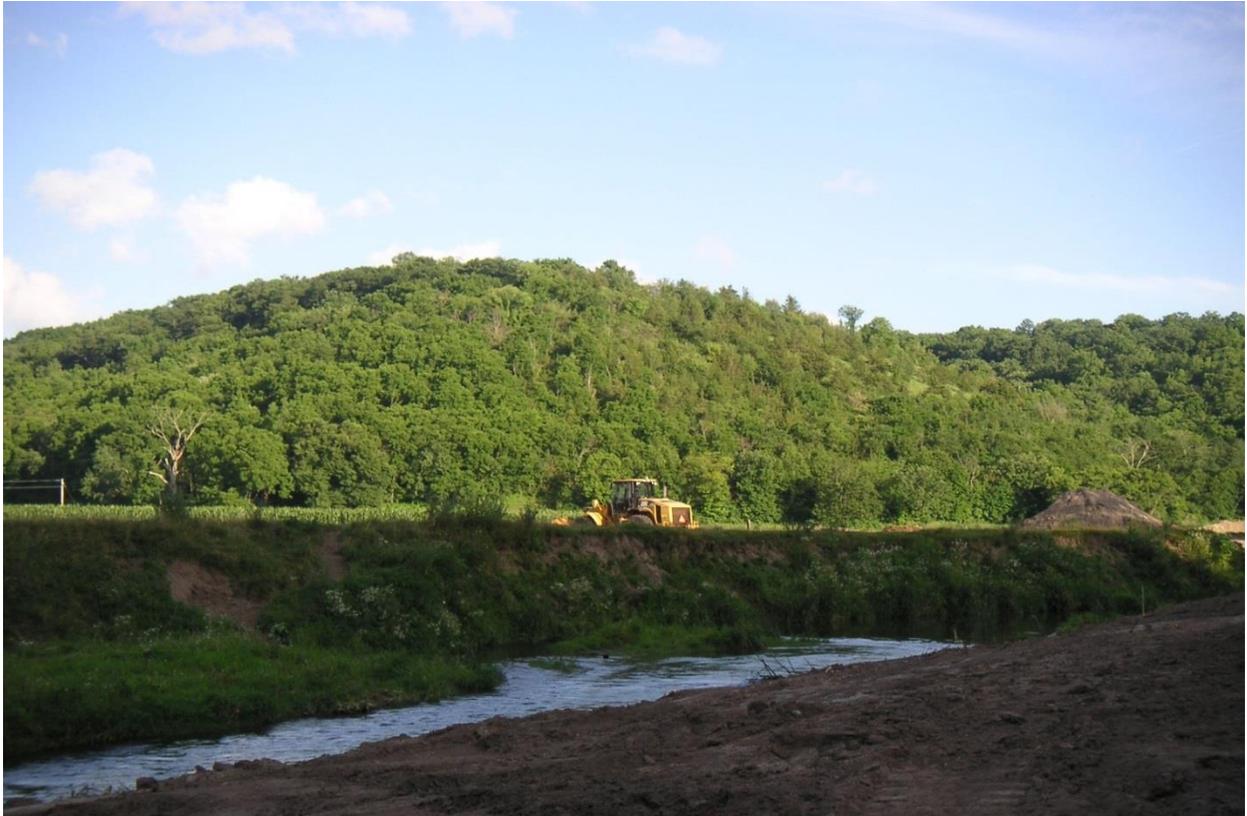
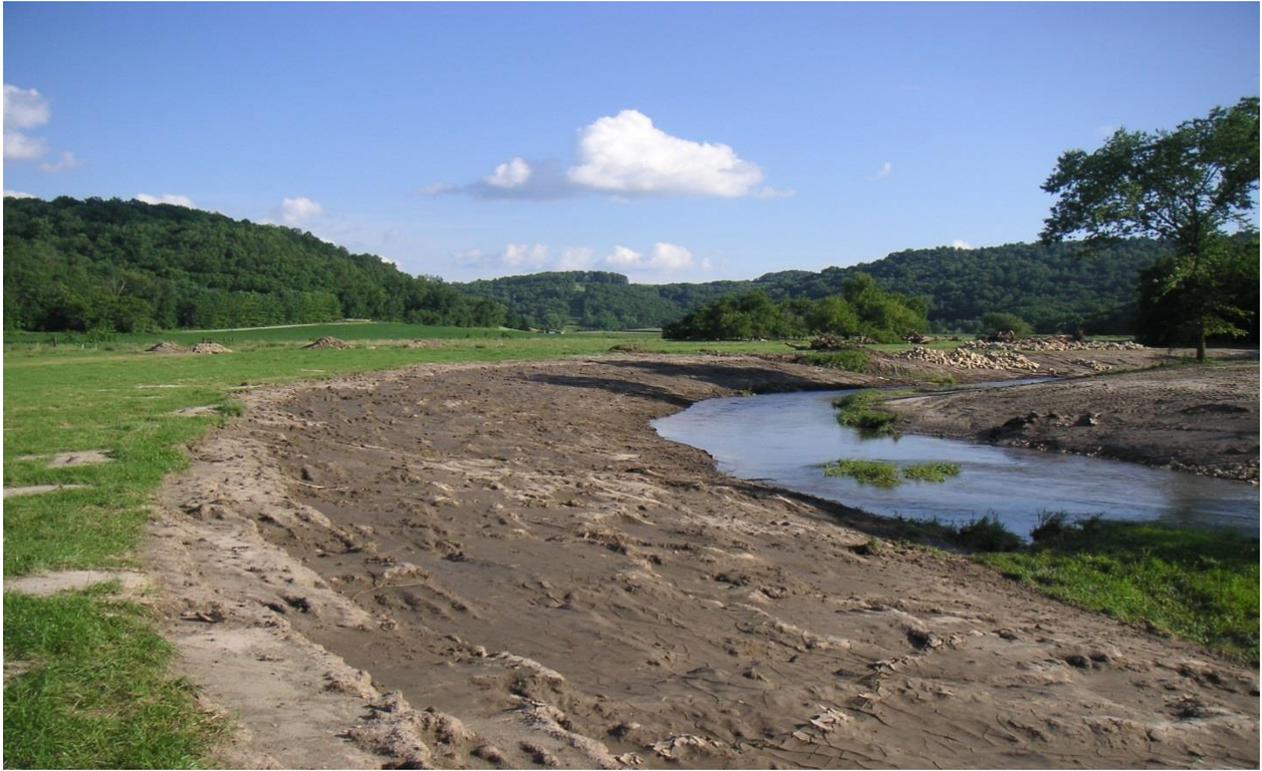
The photo above was taken after a large rain event. You can see where the stream rose all the way to the top of this tapered bank. This is the outside bank in the photos on the previous page. It rose this high twice, and went four to five feet out of its banks several other times. This caused us to have to reseed this site four times. The photo below shows the finished section with grass becoming established.

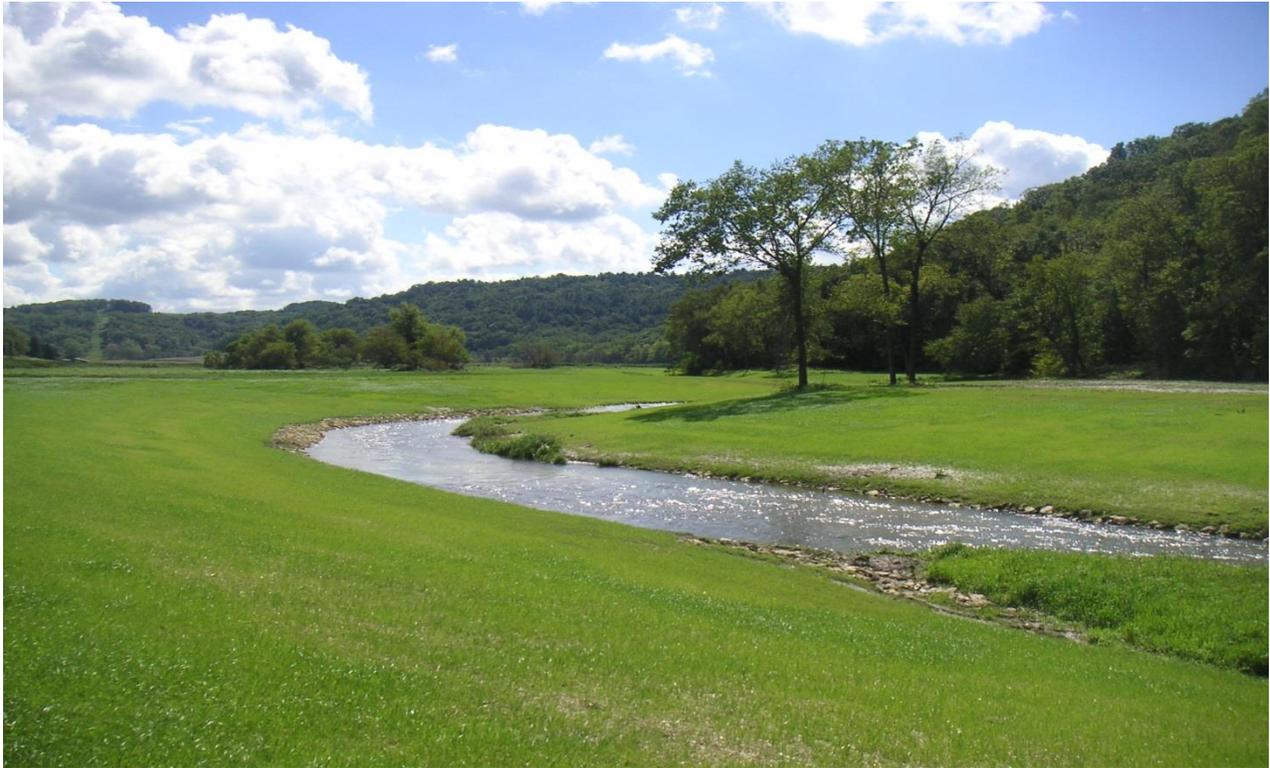
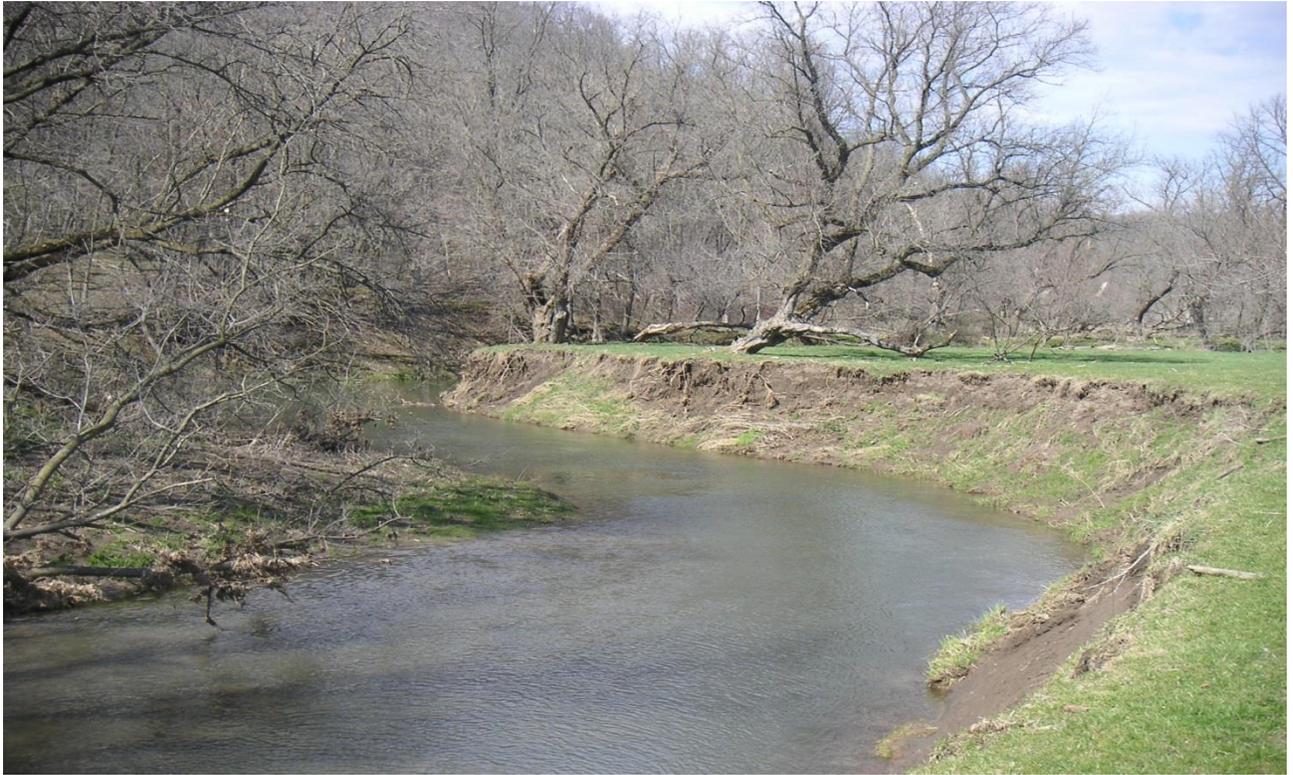
The raw high banks in the top photo are another example of what existed throughout the majority of the project site. The lower after photo shows the same site after bank shaping, and a weir, root wad, and two log deflector sets were installed.

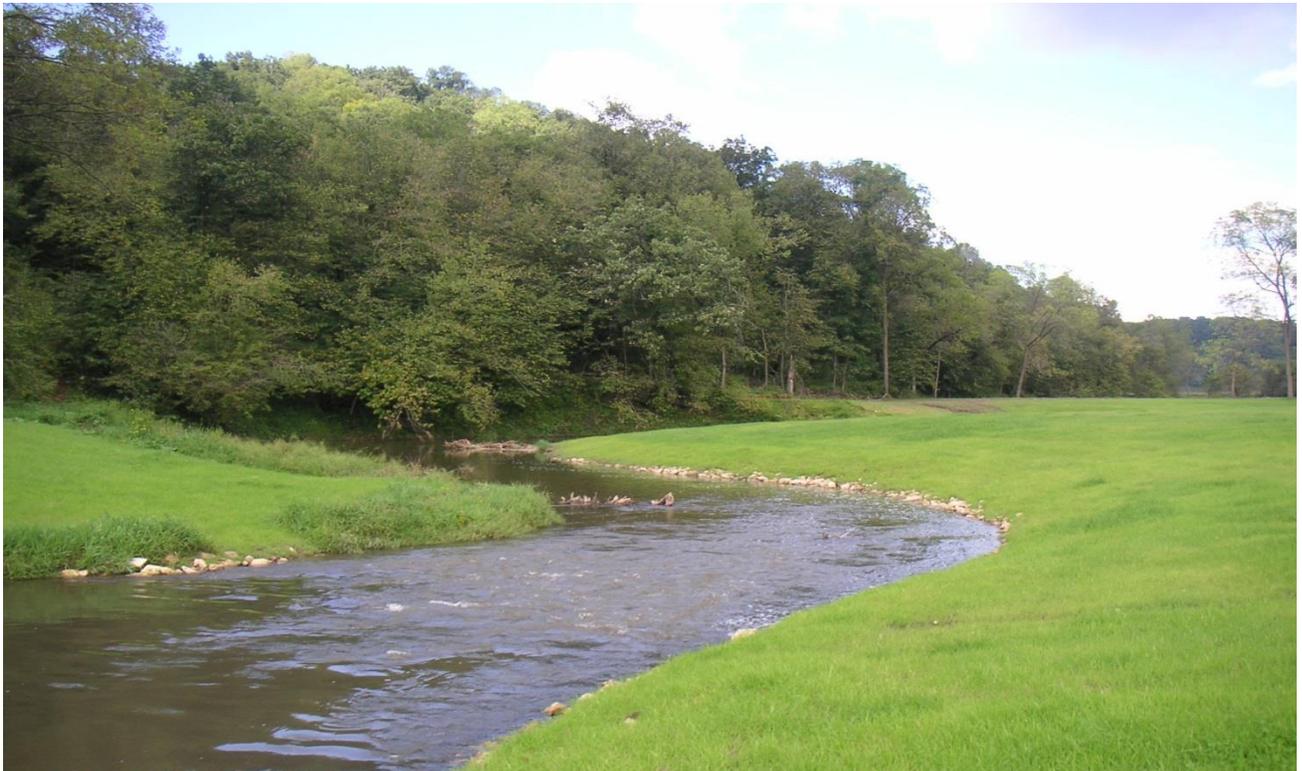
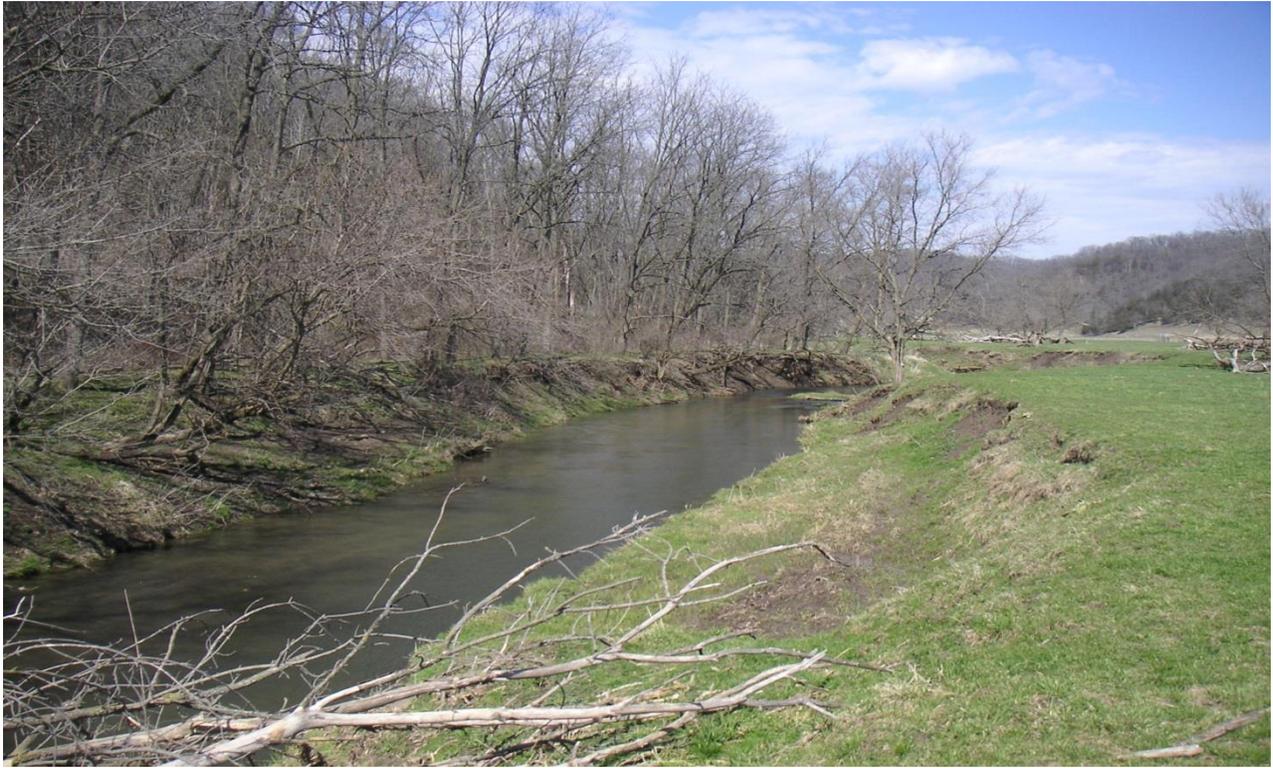
This before and after sequence is from the upper most section of the 2016 project site. We crossed the fence that exists just above this photo and separates this pasture section from the field section that was the end of the 2012-13 project site. This tied the two finished projects together.
